NEWLAND HOMES

In respect of COLLIN LANE, WILLERSEY

Stage 1 Road Safety and Mobility Audit

November 2015

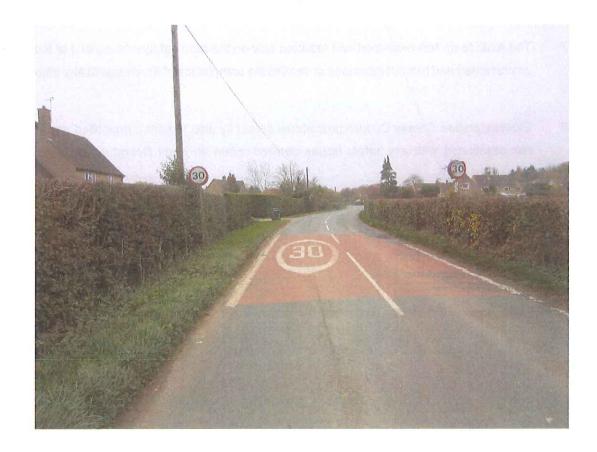
Location: Collin Lane Eastbound approach to the proposed junction.

Summary: There is a 30 mph speed limit approximately 40m from the proposed junction. This limit is at the end of a derestricted speed section. The recorded 85% speeds of 45 mph are considerably in excess of the posted speed limit. Although the visibility splays noted on the drawings are satisfactory for the recorded speeds there remains the risk that vehicles emerging from the site will underestimate these approach speeds with the risk of accidents with turning vehicles.

Problem 2.1 This is assessed as MEDIUM Risk based on one Slight accident every 5-10 years.

It is recommended that the site of the 30 mph limit is visually reinforced within the existing verge to provide a village entry point, with appropriate 'Willersey' village signage and gateway features to assist reduction of speeds to within the posted limit.

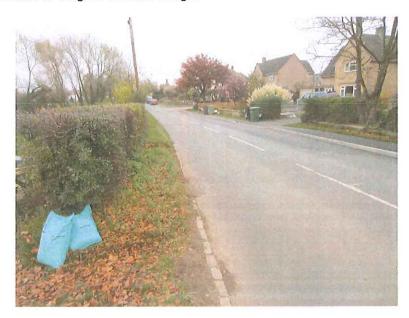
Location: Collin Lane footway from the development to provide pedestrian link to Willersey Village East of Collin Close.

Summary: The proposed footway appears to be constrained by the existing hedge at the East end. It appears that the proposed width of 1.5m might not be accommodated within the existing verge. If the footway is too narrow pedestrians might be forced into the carriageway, with the risk of being struck by passing vehicles.

Problem 2.3 This is assessed as LOW Risk based on one Slight accident >10 years.

Engineer the proposals onto a topographic survey to confirm the detailed realignment of the existing kerbline that will be required to deliver the required footway width. This can be considered further at Stage 2 detailed design.

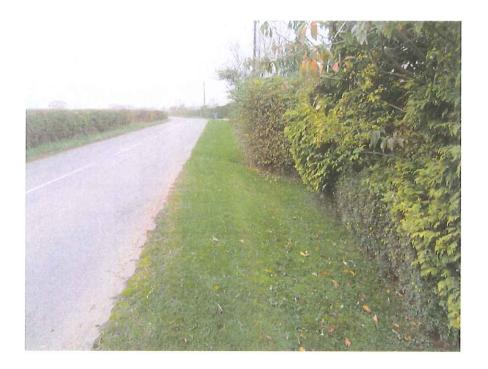
Location: Proposed footway in Collin Lane along the 'Hopefield' frontage.

Summary: There is an existing ditch in the vicinity of the proposed back edge of the footway that may require the proposed footway width to be reduced to 1.5m. Pedestrians may step off the edge of the footway with the risk of injury.

Problem 2.4 This is assessed as LOW Risk based on one Slight accident >10 years.

Consider proposed levels, the width of the proposed footway, and the back edge in more detail to confirm that the proposed construction does not introduce a step-off hazard. This can be considered further at Stage 2 detailed design.

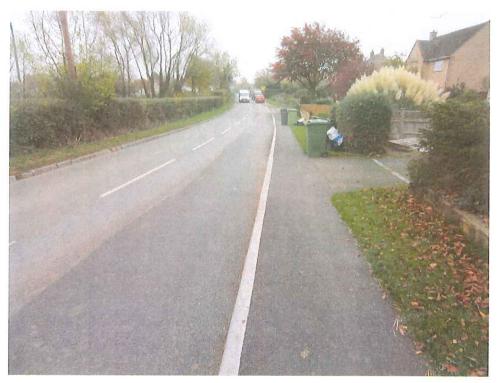
4.1 It is noted that the existing footway in Collin Lane between the end of the proposed footway and the village centre is in places less than 1m wide.

Existing Collin Road footway East of Collin Close
